## **APPENDIX B      AGENCY CONSULTATION**

Final Supplement-II to Final Site-Wide Environmental Assessment:  
National Renewable Energy Laboratory South Table Mountain Site

Subject: Department of Energy's New Southern Access to the National Renewable Energy Laboratory South Table Mountain Site

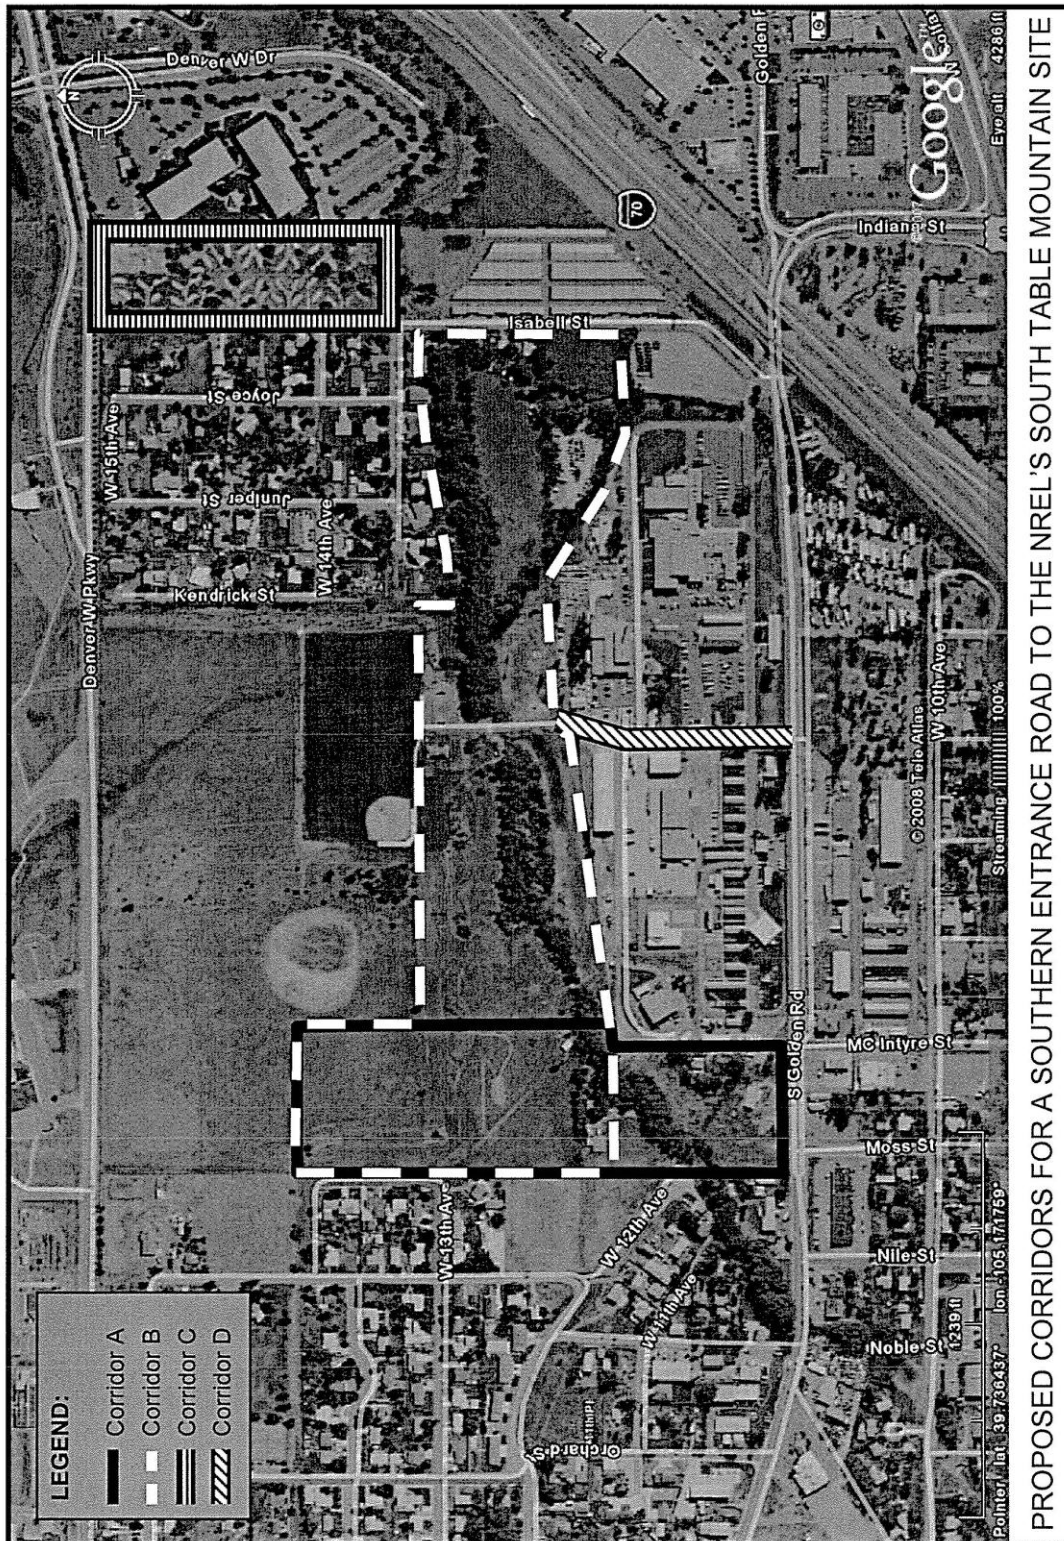
PROPOSED CORRIDORS FOR A SOUTHERN ENTRANCE ROAD TO THE NREL'S SOUTH TABLE MOUNTAIN SITE

As shown in the attached Figure, four Corridors (A, B, C and D) are being considered at this time. As part of the roadway entrance design, all alternatives would require crossing Lena Gulch and, therefore, may be the subject of potential permit requirements under the Nationwide Permit Program. Alternative A would require a new bridge. Alternatives B and D could use an existing bridge on Kilmer Street, possibly with some upgrades, or a new bridge may be needed. Alternative C would utilize the existing bridge on Isabell Street.

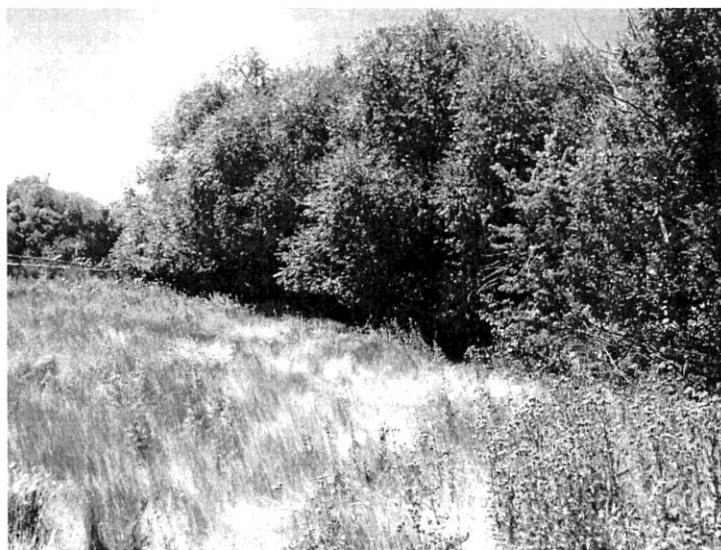
Photo 1. Riparian forest gallery line Lena Gulch.

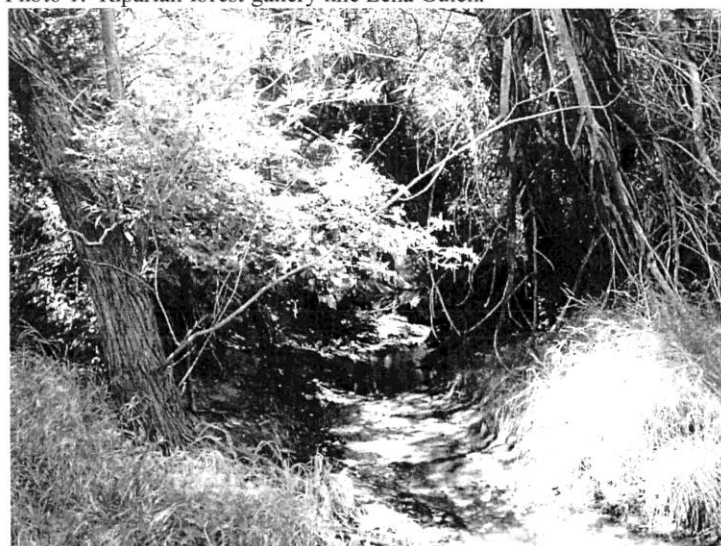
Photo 2. Understory along Lena Gulch is primarily grasses.

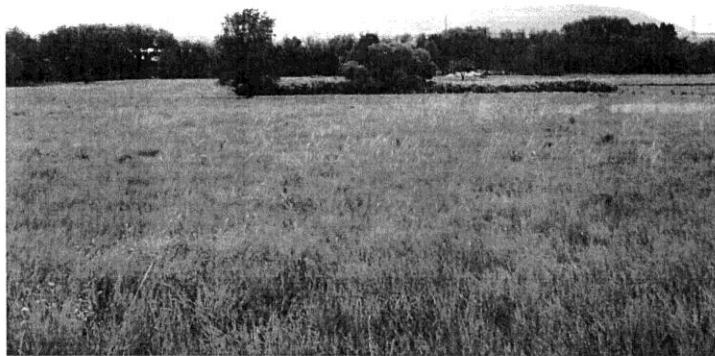
Photo 3. An isolated patch of willow shrubs found north of Lena Gulch. Lena Gulch is in the background of this photo with the willow patch in the mid-ground.

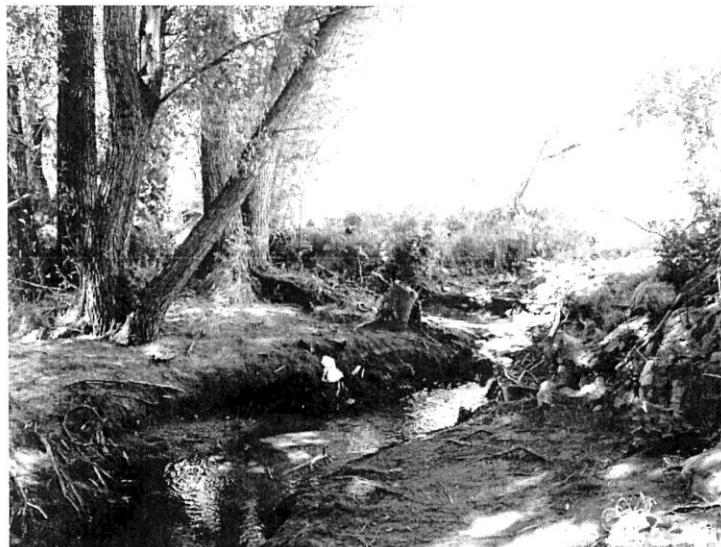
Photo 4. Lena Gulch is incised for most of its length through the Pleasant View Park.

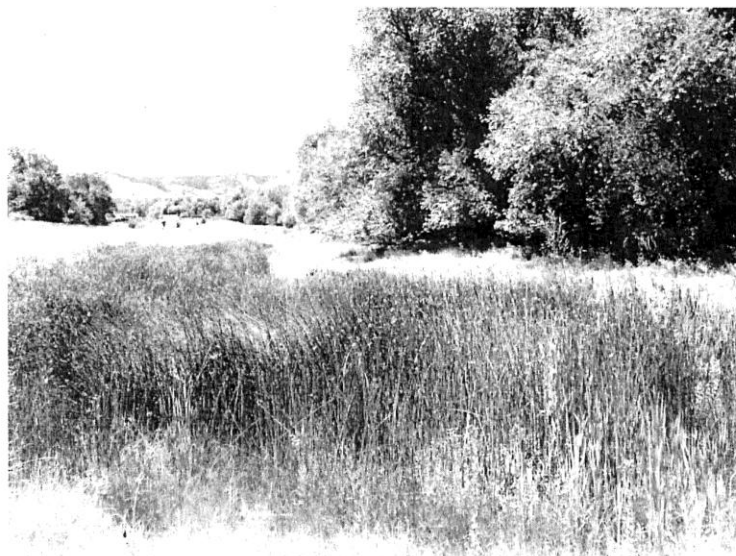
Photo 5. Constructed wetlands and flood storage channel adjacent to the south bank of Lena Gulch.

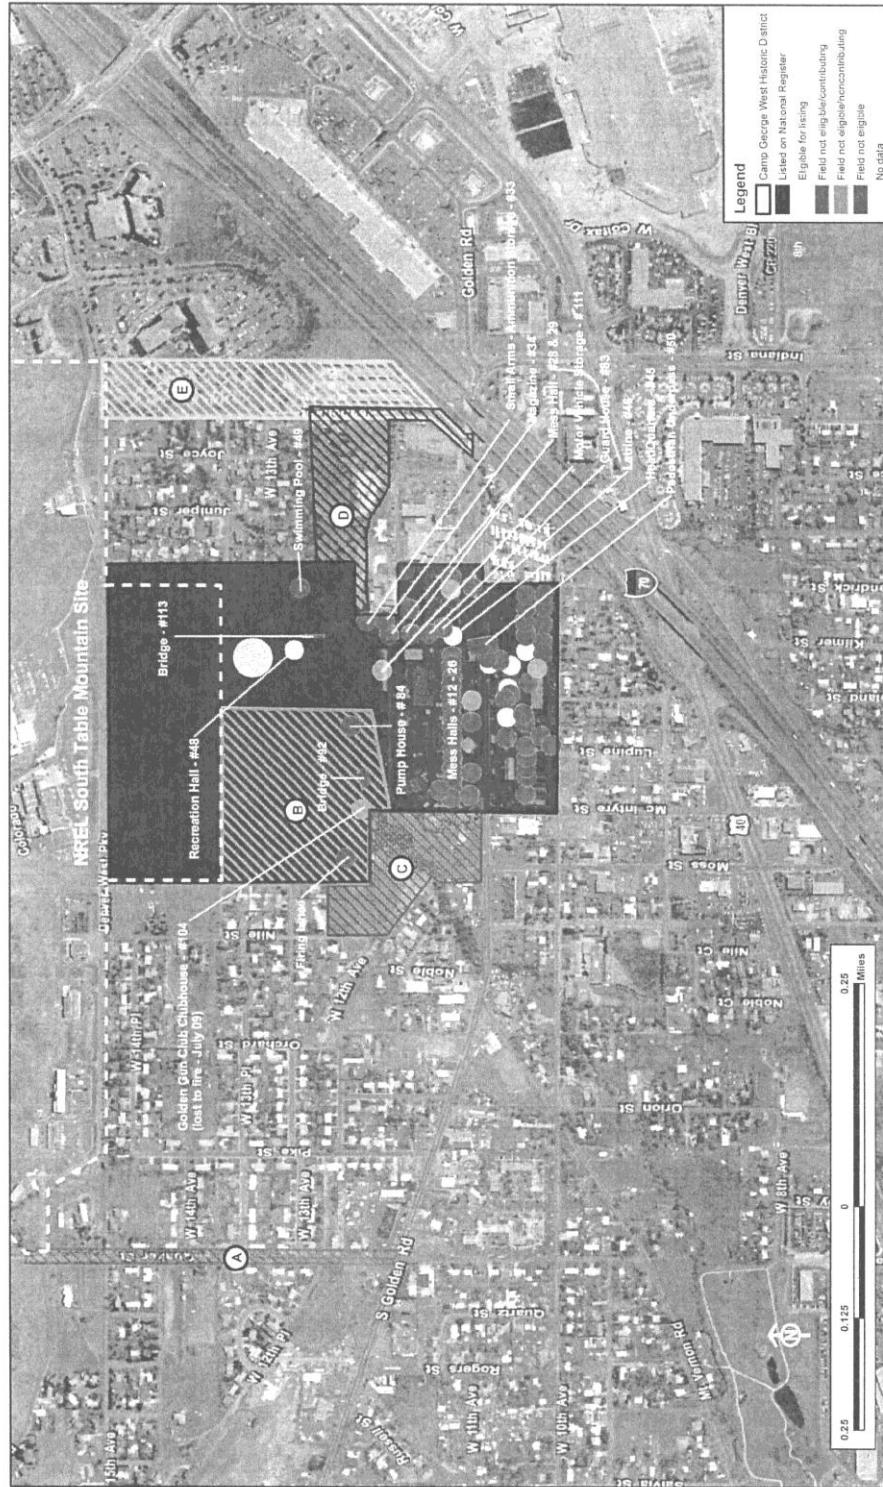
Figure A-2. Camp George West Historic Resources within the Proposed Corridors for a Second Full Service Access Road to the NREL's South Table Mountain Site

The following sections describe the buildings and structures that could be affected if one of the five proposed corridors were built. The locations of these resources are shown on Figures A-1 and A-2.

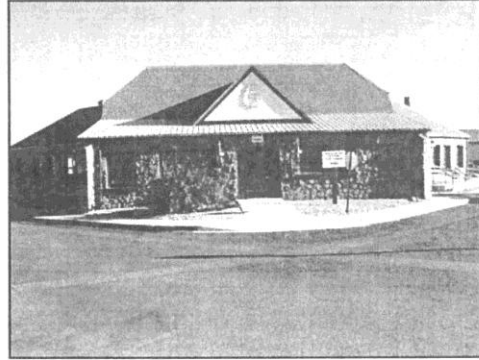
*Headquarters (Building 45)*

A focal point of the post is the headquarters building erected in 1937 with funding from the WPA. The building was designed by George H. Merchant to employ as many hours of labor as possible in its construction, thereby providing employment for public relief workers. Included in the design were a complex roofline, many windows, and several wall projections. The one-story split fieldstone building has a central bay with a steeply pitched roof intersected on each end by roof wings. The central bay has a low, shed-roofed projecting façade presenting the building's central entrance. Above the entrance is a pediment arch that is stuccoed and decorated with the state seal. The entrance is flanked by a pair of casement windows with concrete sills. Flanking these are large 16-pane windows.

At the corners of the main bay are engaged stone pilasters. In 1956, a frame addition was added to the eastern wing of the building. The main entrance has been remodeled, as have entrances on the east and west wings.

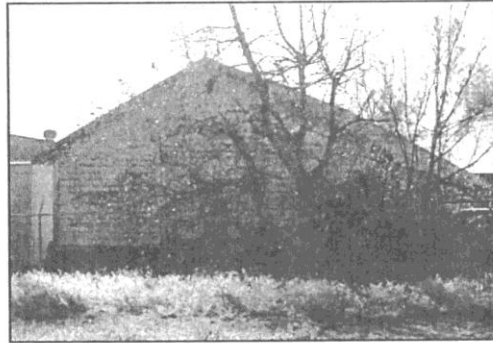
*Small Arms/Ammunition Storage (Building 33)*

This one-story rectangular frame building has tongue-and-groove siding and a gabled roof with overhanging eaves and exposed rafters. The northern elevation has a central sliding wooden door that opens onto a small loading dock and is flanked by small multi-pane windows. A second sliding door is on the west. Windows are mostly six-pane with wood trim. One window on the east elevation has been replaced with a metal vent.

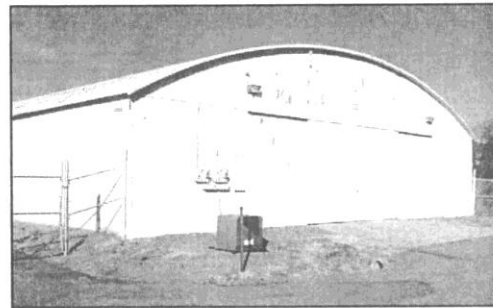
*Motor Vehicle Storage (Building 111)*

Built in 1953, after the period of significance (1903 to 1945), Building 111 was constructed north and west of the Headquarters and Guardhouse. This quonset-hut-style building has been designated a noncontributing resource, meaning it lacks any associations, qualities, or values that would contribute to the significance of the Camp George West Historic District.

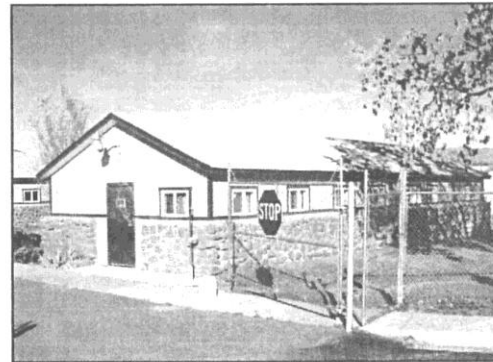
*Mess Hall (Building 12)*

This building is one of 11 remaining of 17 mess halls built during the period 1936-1941 on the post. It is representative of the current appearance of the buildings. This mess hall is a one-story front gable building with overhanging eaves. The lower portion of the building to sill height is composed of quarried basaltic stone rubblework; the upper walls are frame, now covered with nonhistoric siding over the original horizontal tongue-and-groove siding. The building has central entrances on gable end walls. The south entrance originally had double doors but now has a single door. Side elevations had central doors that are now covered up. Original six-pane windows have been replaced with sliding windows. Original corrugated iron roofing has been replaced with shingle roofing.

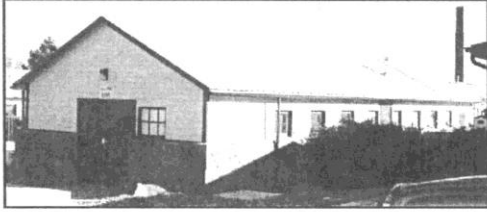
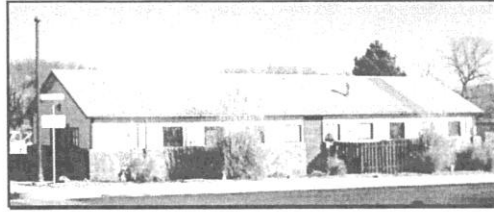
The basic design of these mess halls, built approximately 5 years after Building 12, was essentially the same as the design for Building 12. However, the stone masonry on the lower portion of these buildings is more polygonal, with the stones quarried to a flatter surface.

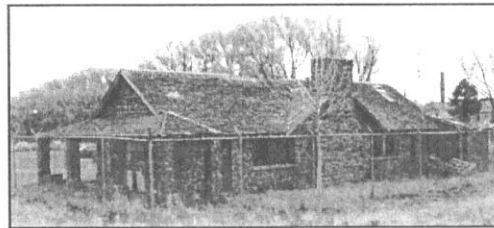
*Recreation Hall (Building 48)*

This one-story building was designed to accommodate leisure-time activities of Guardsmen as a WPA public works relief project. The walls of the building are composed of fieldstone set with wide mortar seams. The cross-gabled roof has widely overhanging eaves, decorative beams, and exposed rafters. A projecting, gabled, central entrance bay is flanked by wraparound porches with stone pillar supports and walls. Over the entrance is a flat stone lintel. All windows have multiple panes (six or eight) and cast cement sills. The interior features a large fieldstone fireplace. The building has nonhistoric doors, the windows have metal grills, and a portion of the porch has been enclosed.

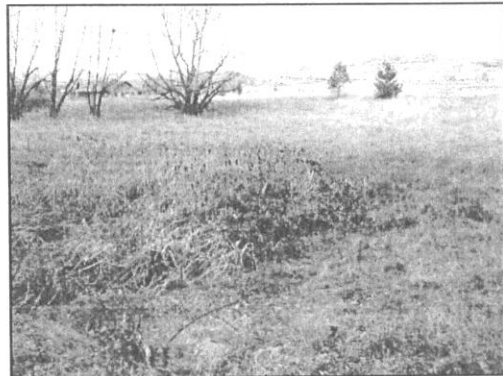
The concrete outdoor swimming pool is no longer in existence; in its place is a wetland. The pool, built as a public works relief project, was a 50- by 90-foot rectangle that varied in depth from 3 feet on the western shallow end to 8 feet on the eastern end. The edge of the pool was surrounded by a narrow wall approximately 18 inches high, which was topped by a flat concrete top. An L-shaped concrete bench was located northwest of the pool. The pool originally had a diving board in the center of the east end and metal access ladders adjacent to the diving board and at the northeast and southeast corners. The pool was enclosed by a chain link fence.

*Wetland occupying the original location of the outdoor swimming pool (Structure 49)*

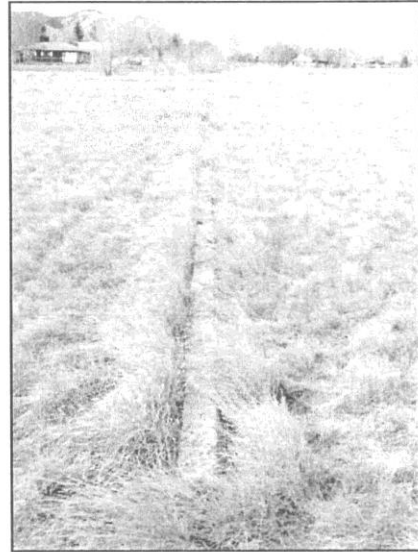
*Rifle Firing Range (FR12)*

Located northwest of the principal concentration of buildings at Camp George West, on the western edge of the installation, the lines of the firing range are oriented east-west and consist of a 600-yard line (farthest to the south), a 500-yard line, a 300-yard line, and a 200-yard line (farthest to the north). The lines are constructed of concrete, approximately 340 feet long and 1 foot wide, flush with the ground on the side of the shooter and about a foot above the ground on the side of the target. The 600-yard line is intact; the remaining three are missing segments where a dirt road and/or channelized drainage cuts through the lines. The rifle range was utilized during summer encampments of the Colorado National Guard during the 1920s and 1930s. During World War II, the 757th Military Police Battalion used the range.

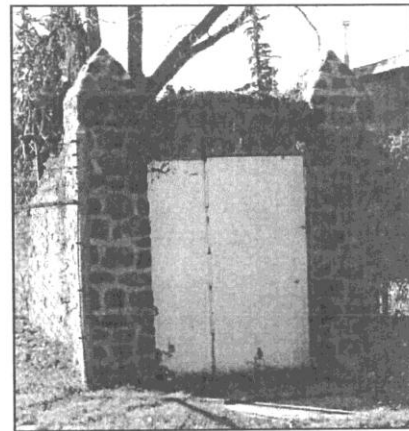
*Pedestrian Underpass (Structure 50)*

A Civil Works Administration project completed this pedestrian tunnel under South Golden Road and the Denver and Inter-Mountain railroad tracks to connect the northern and southern portions of the camp. The concrete-lined passageway consists of steps and a tunnel with sloping floors toward a level midsection. Entrances on either end are wedge-shaped and composed of split fieldstone. Stone posts with pyramidal tops stand at the corners of the entry and extend beyond the roofline. The roof is slightly curved and covered with a thin layer of concrete. The entrance on the southern end is open, while the one on the north is covered with a metal door and siding.

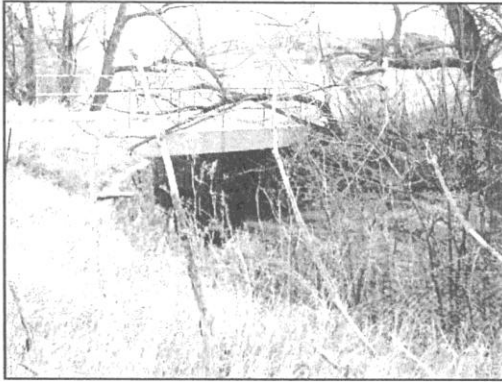
*Bridge (Structure 92)*

This bridge over Lena Gulch was built as part of the WPA project to improve the post and provided easier access to the northwest quadrant of the camp and firing range. The one-lane bridge has a reinforced flat concrete deck and a 10-foot roadway with a 3-foot sidewalk on the east. The span of the bridge is 14 feet. The bridge abutments are composed of roughly split basaltic stone laid in courses. The side walls of the bridge are flared, rounded, and tapered and have a top layer of concrete.

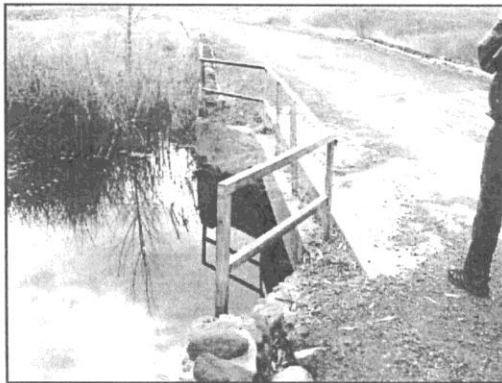
*Bridge (Structure 113)*

This two-lane bridge in the north-central section of Camp George West was constructed in 1938 as a WPA project. The bridge separately spans Lena Gulch and an unnamed tributary to that stream. It has a reinforced concrete slab deck and split fieldstone abutments with thick mortar. The roadway is 20 feet wide with stone walls higher toward the center of the bridge, where the land drops off beneath. A layer of projecting fieldstones is cemented to the top of the bridge walls, and metal railings flank the bridge deck. The total length of the bridge and its approaches is approximately 140 feet.

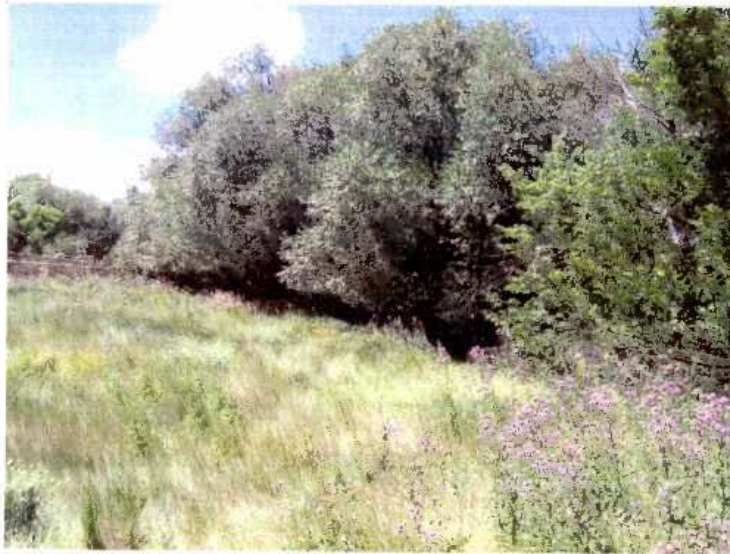
Photo 1. Riparian forest gallery line Lena Gulch.

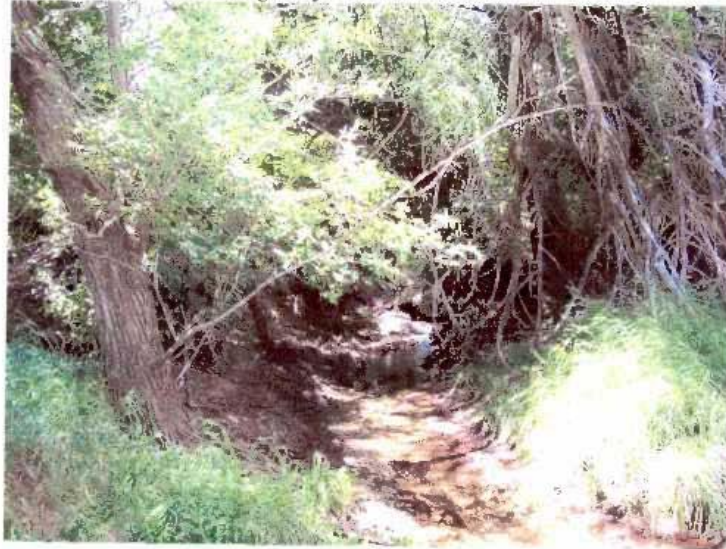
Photo 2. Understory along Lena Gulch is primarily grasses.

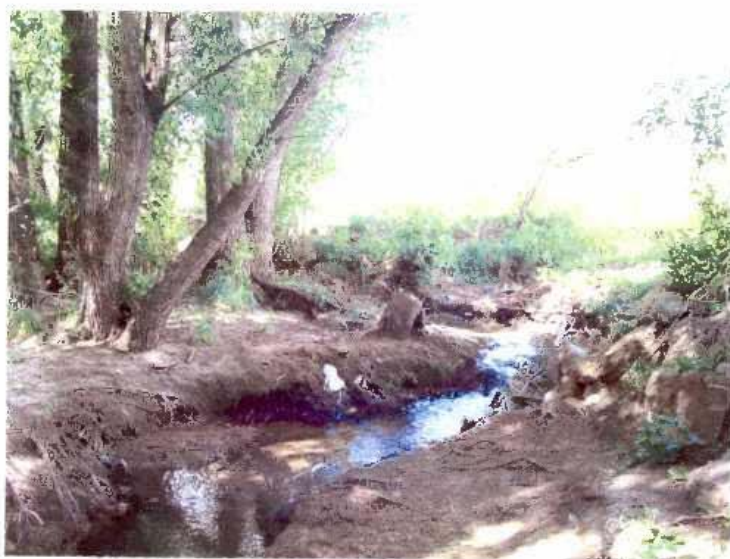
Photo 3. Lena Gulch is incised for most of its length through the Pleasant View Park.

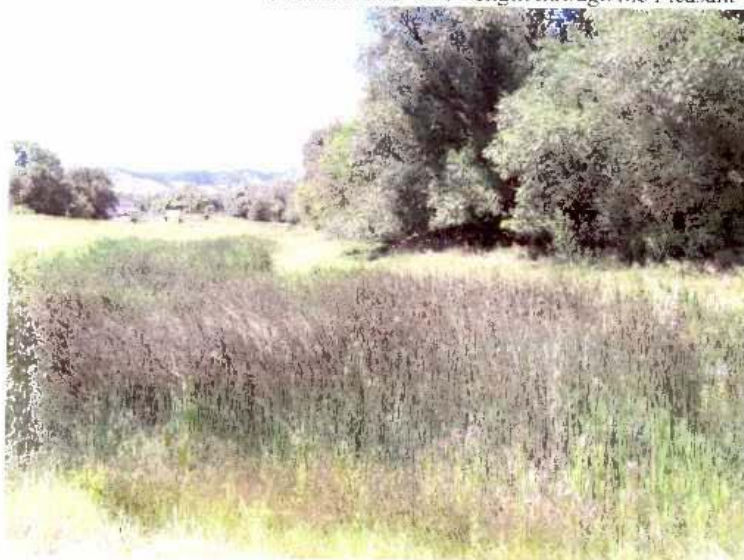
Photo 4. Constructed wetlands and flood storage channel adjacent to the south bank of Lena Gulch.
